Monitoring Cruise at the Portland Disposal Site July 1992

Disposal Area
Monitoring System
DAMOS

Contribution 108 January 1996

Report No. SAIC-C110

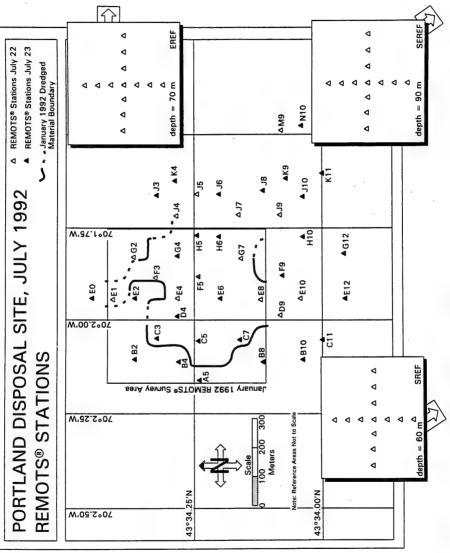
Figure 2-3. July 1992 REMOTS® stations at the Portland Disposal Site

The REMOTS® stations surveyed in July were chosen to further define the boundaries of the dredged material and to determine the status of benthic recolonization at the site. Fourteen REMOTS® stations were surveyed on July 22 (Figure 2-3). Seven of these stations (E1, G2, F3, E4, H5, G7, E8) were also surveyed in January. The seven stations outside of the boundary of the January survey (I4, J5, I7, D9, I9, M9, E10) were surveyed to further delineate the dredged material boundary. After reviewing the REMOTS® photographs from these 14 stations for the presence of dredged material, an additional 28 REMOTS® stations were sampled to demarcate further the dredged material boundary and to gain more information on benthic recolonization on the cap.

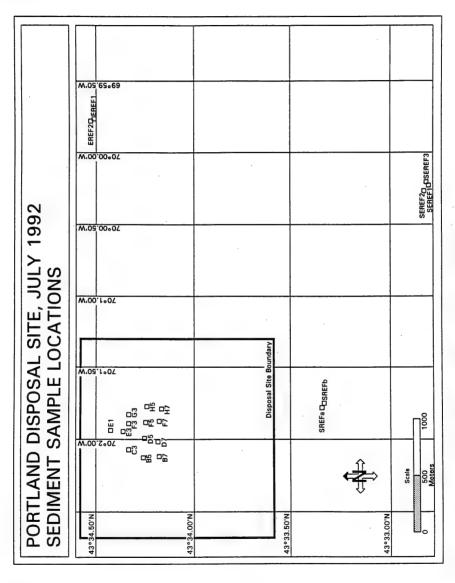
Sediment sample locations at the Portland Disposal Site, July 1992 Figure 2-4.

Sediment samples were collected from the center of the three PDS reference areas (SREF, SEREF, and EREF) and from 13 stations located within the lateral limits of the cap at PDS (H5, F5, D5, B5, H7, F7, E1, F3, G3, E3, C3, D7, B7). The stations on the cap correspond to the REMOTS® stations. The sediment samples were collected with a 0.1 m² teflon-lined Van Veen grab sampler. Three samples were collected for analysis at SEREF, and two were collected from EREF and SREF due to difficulty in collecting sediments. One grab sample was collected from each of the 13 stations on the cap (Figure 2-4). Each grab at the reference stations was subsampled for metals, polycyclic aromatic hydrocarbons (PAHs), and grain size and % total organic carbon. The grabs from the surface of the cap sediment were subsampled for metals and grain size. Sediment to be analyzed for metals and PAHs was placed in precleaned (acid-washed) glass jars. Sediment to be analyzed for grain size and % total organic carbon (TOC) was placed in plastic bags. Samples were kept cold (approximately 4° C) and delivered to the NED laboratory.

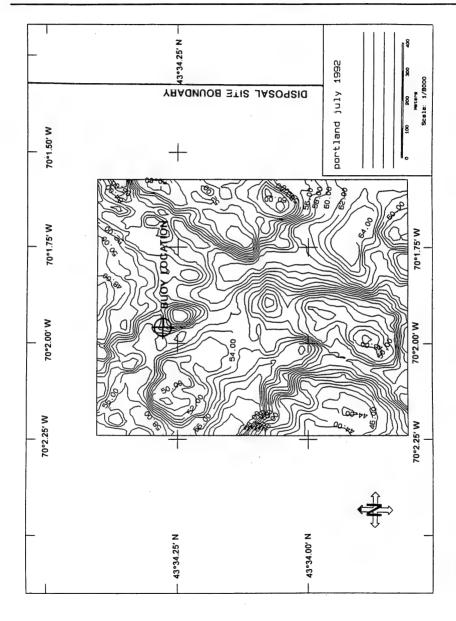
Figure 3-1. Contoured bathymetric chart of the Portland Disposal Site, July 1992 (depth in meters)

The Portland Disposal Site varies in depth from 42 to 64 m (Figure 3-1). The higher elevations are hard rock ridges with steep slopes that enclose more gently sloping sandy valleys. The ridges are located in the southwest corner of the site (minimum water depth of 43 m), at the northern border of the site (minimum water depth of 45 m), and to the east (minimum water depth of 49 m). These ridges enclose two main valleys. One, centered at approximately 43°34.167′ N, 70°02.167′ W, trends northwest to southeast and has a maximum depth of 60 m. The other valley trends north to south in the center of the site and slopes to a maximum water depth of 64 m.

The July 1992 bathymetric survey identified a well-defined mound just south of the buoy location. The mound is approximately 100 m in diameter and 7 m in height (minimum water depth 49 m; Figure 3-1). The location and shape of the mound appear to have remained unchanged since 1989 (Figure 3-2).

The July 1992 bathymetry at PDS showed a mound at the same location as the January 1989 survey (Figure 3-1, 3-2). The depth difference comparison of these two surveys (Figure 3-3) indicated an accumulation of 1 m about 25 m east of the 1992 buoy. Below 43°34.100′ N, another broad area of accumulation is also seen. Negative depth differences between 1989 and 1992 (Figure 3-4) are clustered along steep slopes. These are most likely caused by surveying lane offsets over steeply sloping hard rock ridges (Germano et al. 1993). The extensive areas of dredged material accumulation are not on the steep slopes and are therefore not affected by lane offsets.

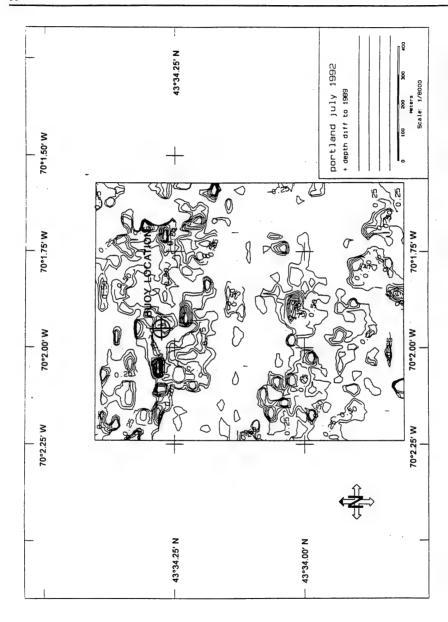
Positive depth difference contour chart (in meters) based on the comparison of 1989 and 1992 Portland Disposal Site bathymetry **Figure 3-3.**

A depth difference comparison between the January 1989 and the July 1992 bathymetric surveys shows extensive areas of accumulation (Figure 3-3) and isolated areas of loss (Figure 3-4). Accumulations of 0.75 m and 1.0 m are located within a 300 m radius of the buoy location. Below 43°34.083′ N, another broad area of accumulation with similar values is seen. Large (>1 m) positive differences in depth between 1989 and 1992 occur in very localized areas and are marked by dense contour lines. Most areas of negative depth differences are localized around areas of steeply sloping ridges. Two areas of negative depth difference (southeast of 43°34.250′ N, 72°02.250′ W and northeast of 43°34.000′ N, 70°01.750′ W) are located on the southwest slopes of ridges.

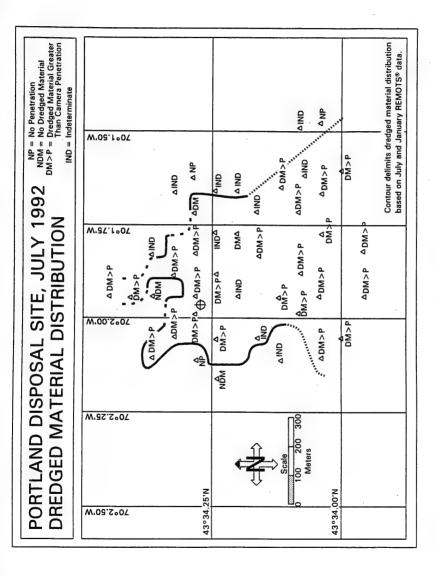
Dredged material location, based on REMOTS®, at the Portland Disposal Site, July 1992 **Figure 3-5.**

The January 1992 PDS REMOTS® survey outlined the dredged material boundary within 250 m of the disposal location (Figure 2-2). The REMOTS® stations in the present survey were chosen to repeat some of the dredged material stations surveyed in January and to further define the dredged material footprint by expanding the survey into ambient bottom.

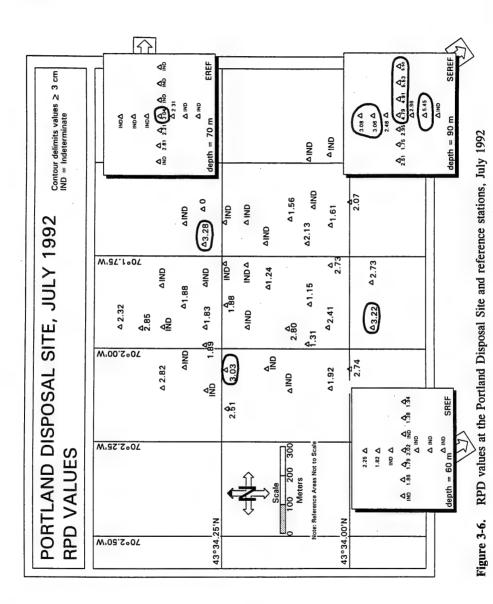
Twenty REMOTS® stations were surveyed in both January and July. In July, fourteen remained dredged material, four remained ambient sediment, one (B2) was ambient and became covered with dredged material, and one (G2) was ambient in January, but the camera did not penetrate the sediment in July (Figure 3-5). In general, penetration depths were shallower for ambient sediment than dredged material.

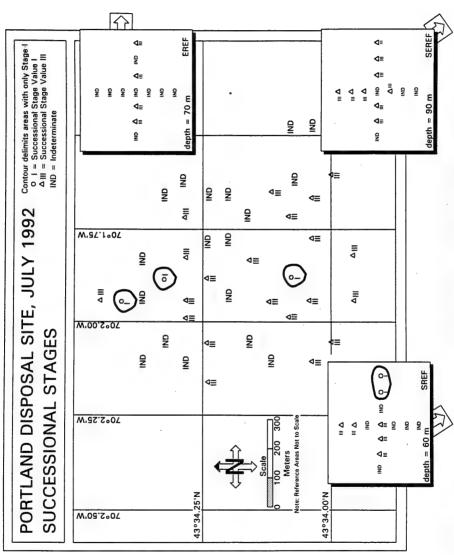
Successional stage values at the Portland Disposal Site and reference areas, July 1992 Figure 3-8.

At PDS, 18 out of 42 REMOTS® stations had indeterminate successional stage values due to condensation on the camera lens. Where the successional stage could be determined, 21 out of 24 stations had Stage III organisms (Figure 3-8). Stage I organisms were found at three stations: E1, F3, and F9. At the reference stations, Stage III seres were found at 17 out of 23 stations. Stage I taxa were found at SREF stations 200E and 300E. Three stations were indeterminate.

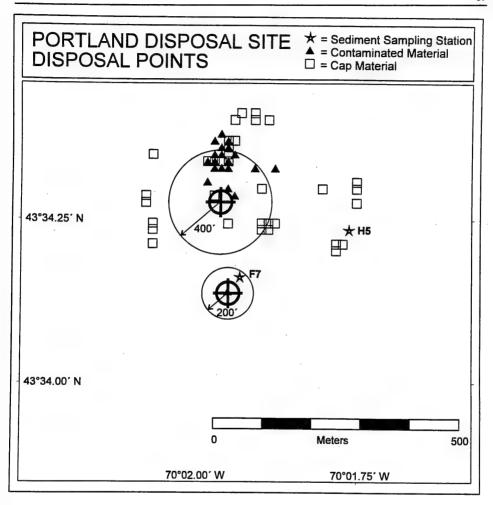
Figure 4-1. Barge disposal release points at the Portland Disposal Site, October 1991 to June 1992

The disposal locations for the material released in 1989/1990 and for the USCG capping project correspond to the areas of accumulation between the 1989 and 1992 surveys (Figure 4-1). There is no apparent accumulation at the release point recorded for the spring of 1991, but there is accumulation approximately 100 m to the south. The July REMOTS® survey detected dredged material around the designated disposal area as well as to the south. The material detected along the southern edge of the deposit may have been a thin layer deposited since 1989 (and therefore undetectable to bathymetric surveys), but it may also have been material that was released prior to 1989 that is still visible in REMOTS® sediment profile photographs.
